Advanced Composite Vertical Fin for L-1011 Aircraft

*Design, Manufacture, and Test
(Executive Summary)*

A. C. Jackson

CONTRACT NAS1-14000
SEPTEMBER 1984

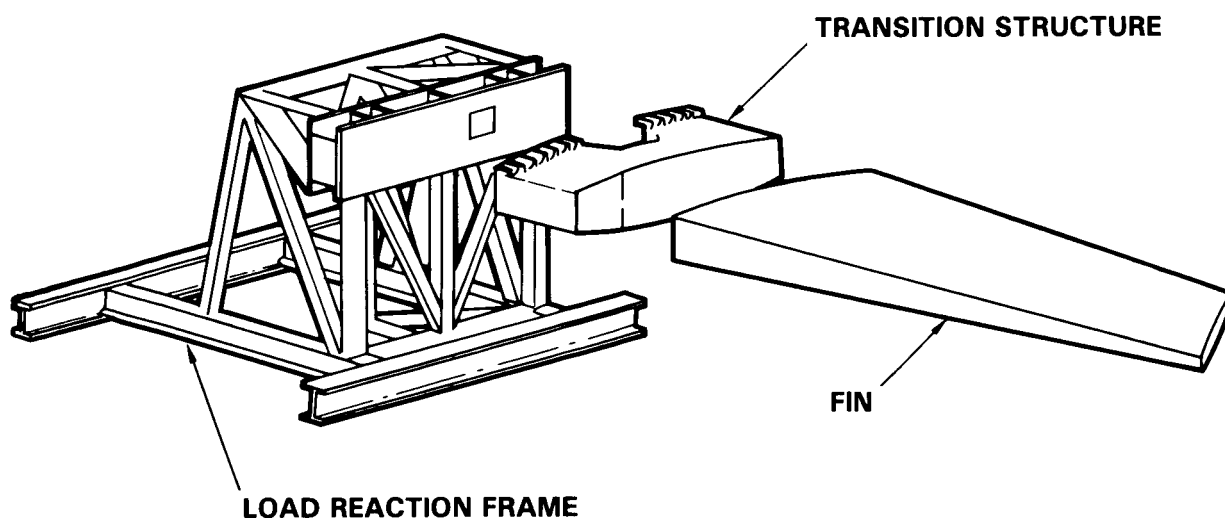
Figure 27. - Test installation of fin in load reaction frame.

The fin and transition structure were attached to the load reaction frame in a horizontal attitude as shown in figure 27.
